The OSSA II Pipeline Oil Spill: The Distribution of Oil, Cleanup Criteria, and Cleanup Operations

EDWARD H. OWENS^{†*} & TONY HENSHAW[‡]

An estimated 29,000 bbl of mixed crude oil and condensate were spilled on 30 January 2000 from the OSSA II pipeline, which was damaged during summer flood conditions, at the Río Desaguadero river crossing on the Bolivian Altiplano. The oil was deposited as far as 370 km downstream along a total of approximately 400 km of river channel banks, meander flood plains, and irrigation ditches, as well as on several hundred hectares of low-lying flood plain wetlands. The oil was transported over a large geographic area but was cleaned up successfully and rapidly, in three months, by a large response operation that involved more than 3600 people, including 3200 local laborers at the peak period, using manual cleanup methods. Second phase cleanup activities after April 2000 focused on oiled vegetation and on man-made canals, ditches and livestock watering holes. Four sets of cleanup end points were used during this response to address specific environmental conditions: the reopening of the Desaguadero river for normal use; the removal of the oil residues;

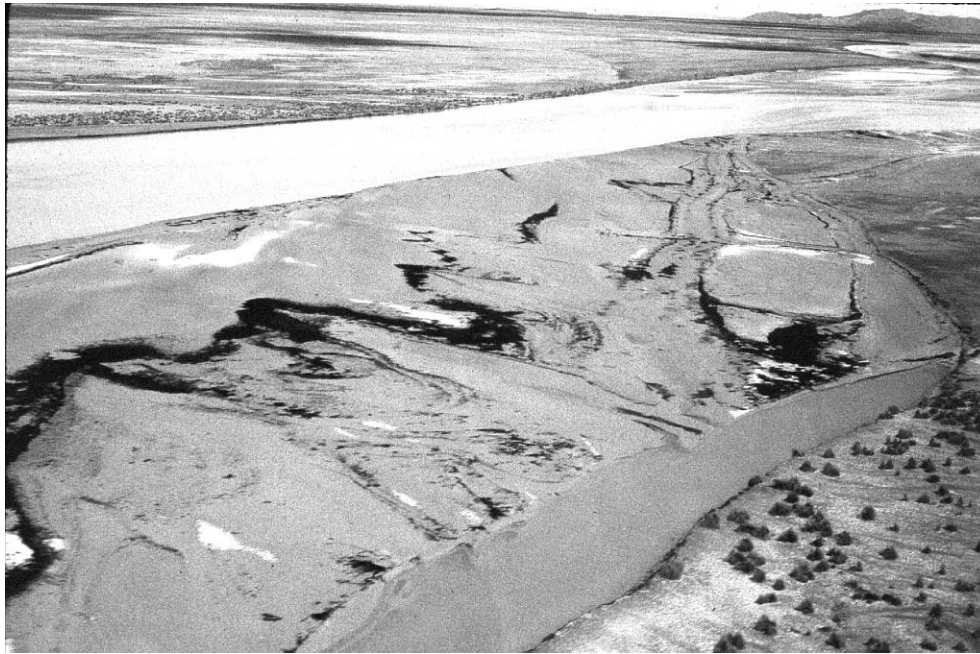
Fig. 5 Aerial view to the west, from approximately 150 m above the ground, of stranded oil on exposed sand bars in Zone 3 on 25 February, 2000. The main channel of the Desaguadero is in upper frame and during the flood stage the water extended to the vegetated area in the lower right.

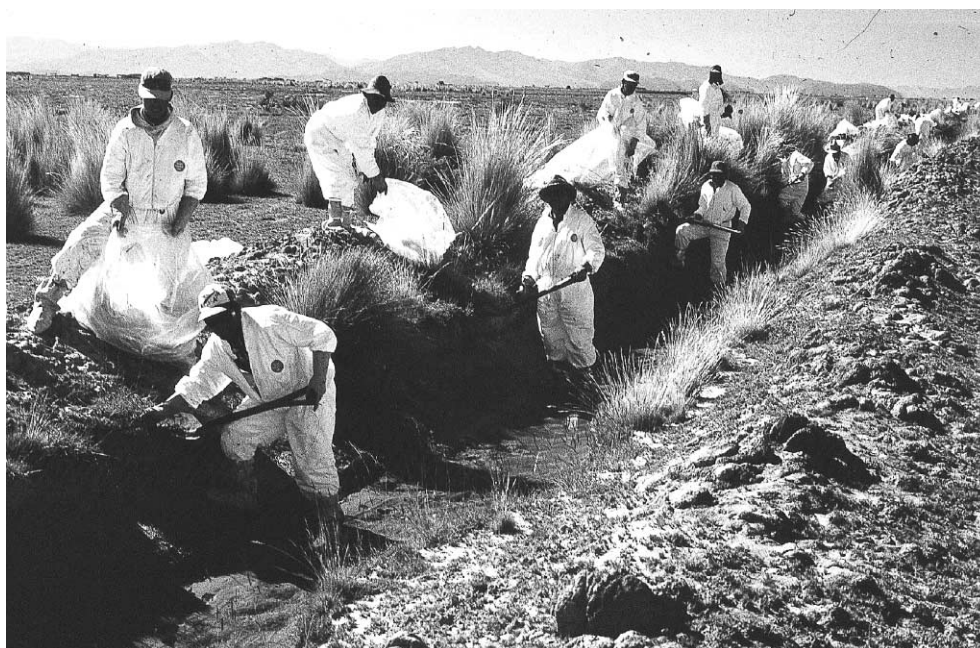
Fig. 6 Cleanup of irrigation canals in Zone 5C, 17 March 2000.

The canals, ditches and watering holes that had observed oil were cleaned (Fig. 6) and locations that were suspected to have oil were sampled. After cleanup the sites were re-sampled (Taylor *et al.*, in preparation).
